Manhole Inspection Summary

Manhole # S57G__014MH

Insp Date: **7/29/08 10:14 AM**

Location Address: **240 s janey st**

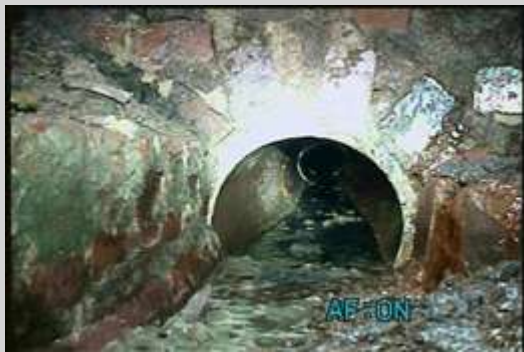
12 O'Clock Outflow

8 in. Circular Gravity Sewer
Pipe Out @ 12 O'Clock

Invert Depth: 7.81 (ft.) Flow Characteristics: **Slow**

Deposits: ☒ None ☐ Mud ☐ Sludge ☐ Debris ☐ Grease

Infiltration: **None** Pipe Seal Cond: **Unknown**

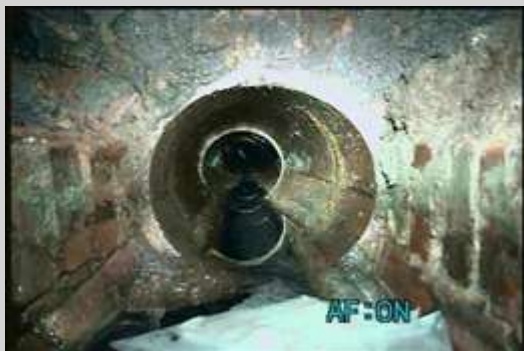
6 O'Clock Inflow

8 in. Circular Gravity Sewer
Pipe In @ 6 O'Clock

Infiltration: **None** Pipe Seal Cond: **Unknown**
